Motorcoach Collision
With Crash Attenuator in Gore Area
US Highway 101
San Jose, California
January 19, 2016

Accident Report

NTSB/HAR-17/01
PB2017-101430

**National
Transportation
Safety Board**

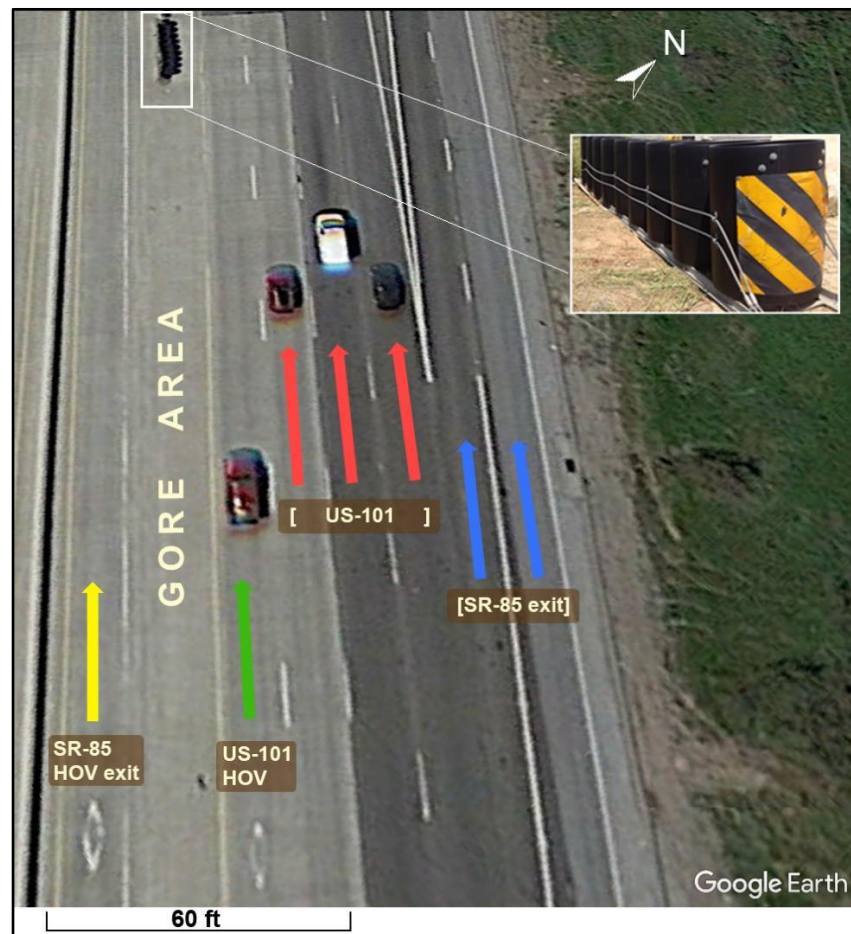
A 990-foot-long gore with an unmarked inside area separates the left exit HOV lane for SR-85 from the US-101 HOV lane. The gore widens to about 22 feet at the point where a reusable energy-absorbing crash terminal (REACT) 350, nine-cylinder crash attenuator is in place, in advance of a 3-foot-high concrete barrier. The barrier physically separates the left exit HOV lane for SR-85 from the US-101 HOV lane.

Figure 2. Depiction of travel lanes and gore area at US-101–SR-85 northbound interchange. Retroreflective object marker on lead cylinder of exemplar crash attenuator, shown in inset, was not present on January 19, 2016. (Source: Google Earth, image date March 28, 2015)

Video evidence shows that the bus was traveling in the US-101 HOV lane (green arrow in figure 2) as it approached the interchange. Then, the driver initiated a movement to the left, into the gore area. But, instead of entering the left exit HOV lane for SR-85 (yellow arrow in figure 2), as the driver reported to the California Highway Patrol (CHP) he had intended to do, he maintained the vehicle's path in the gore until colliding with the crash attenuator. The bus then rode up the concrete barrier, yawed counter-clockwise, and rolled 90 degrees to the right. As shown in figure 3, the bus came to rest on its right side against the concrete barrier, with its aft section resting on the US-101 HOV lane and its front hanging over the left exit HOV lane for SR-85.² The bus had traveled 65 feet from the point of initial impact with the crash attenuator to its final rest position.

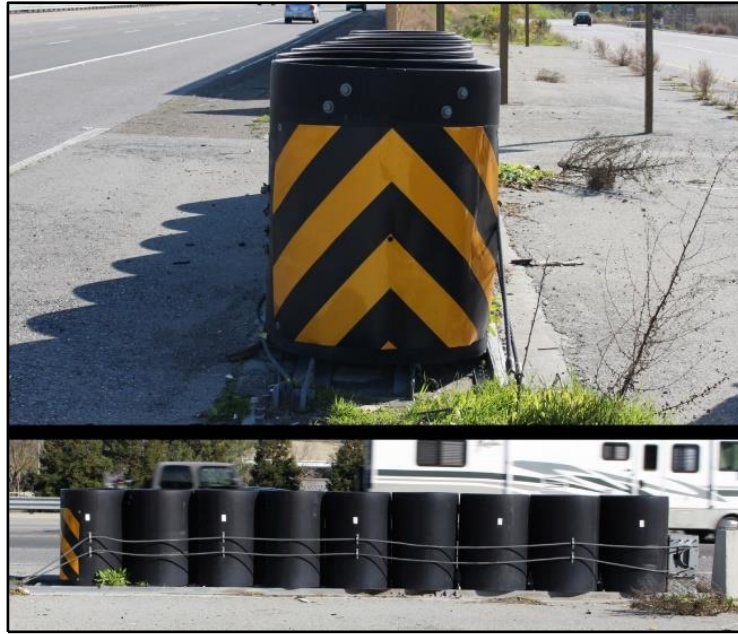
1.5.1.2 Crash Attenuator. A REACT 350 crash attenuator is in place in advance of the 3-foot-high concrete barrier at the end of the gore. The crash attenuator is composed of nine 36-inch-diameter cylinders, which are secured by steel cables and placed on a steel plate anchored into the concrete (see figure 4). By design, the walls of the cylinders increase in thickness from front to rear to absorb impact energy in a controlled manner. The device is classified as a re-directive attenuator that meets test level (TL)-3 criteria (Transportation Research Board [TRB] 1993).¹⁶

Figure 4. Front and side view of REACT 350 attenuator located 1 mile from crash site on US-101 south.

1.5.1.3 Crash History. At NTSB request, Caltrans provided the crash history for a 2-mile segment of US-101. In the previous 8 years, eight crashes occurred at this location, five of which involved a vehicle striking the subject attenuator.¹⁸ The most recent such incident occurred on December 6, 2015—about 6 weeks before this crash—and resulted in displacement of, and damage to, the retroreflective object marker.

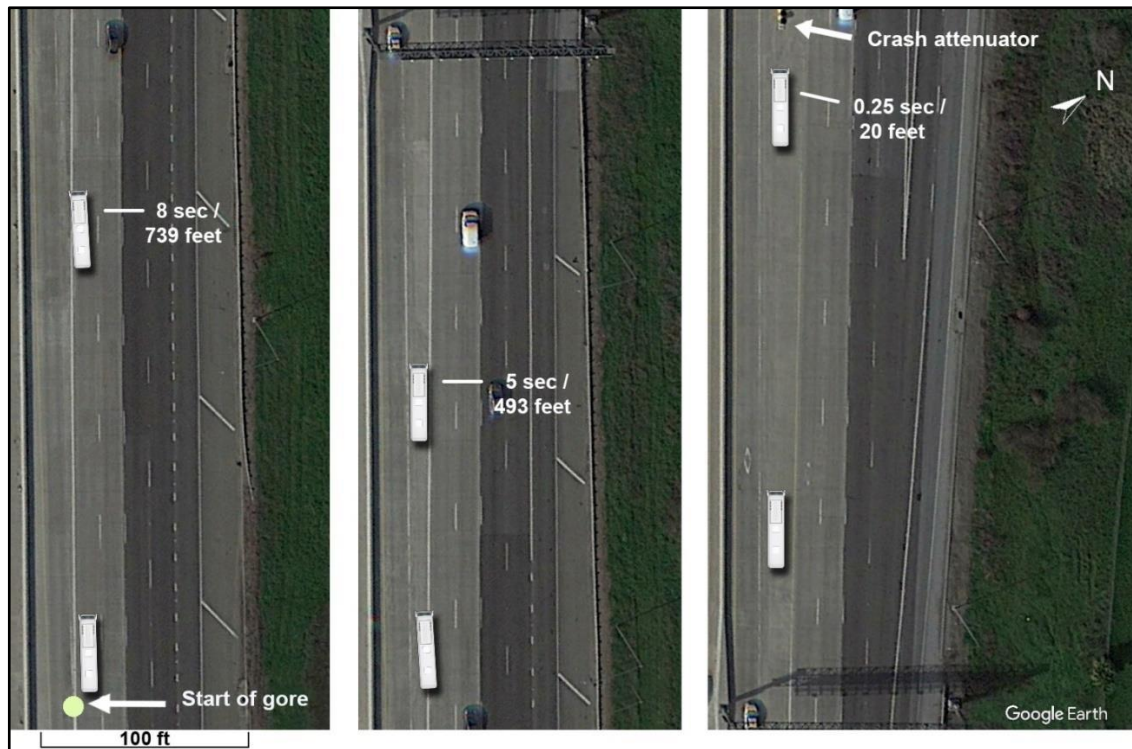
1.6.5.1 Forward-Facing Camera. Because of the positioning of the DriveCam system on the windshield, the forward-facing camera was outside the range of the windshield wipers. Throughout the pre-impact segment of the video, rain droplets are prominent across the entire forward field of view, and other vehicles are moving at the speed of, or faster than, the bus.³² At the start of the recording, the bus is traveling in the US-101 HOV lane, and a solid white line is visible to the left of the bus, along with pavement reflectors. Eight seconds before the crash, about 739 feet from the crash attenuator—the bus begins to move to the left, into the gore area. Three seconds later, about 493 feet from the attenuator, the bus is entirely within the gore, as shown in the middle panel of figure 9.

Figure 9. Depiction of movement of bus into gore and proceeding to point of impact, showing in each panel time to impact and distance to attenuator. (Source: Google Earth, depicting crash location on January 26, 2016)

The video does not show any objects directly ahead of the bus until 4 seconds before the crash, at which point a small reflective object was noticeable. The object was distinguishable 3 seconds later, 1 second before the crash. It was identified as a small exit sign mounted on the concrete barrier, behind the crash attenuator.³³ Also at this time, because of a vertical reflection of light from the headlights, a black object beneath the sign became noticeable.³⁴ In addition, a white object was seen lying flat on the ground behind and to the left of the black object.³⁵

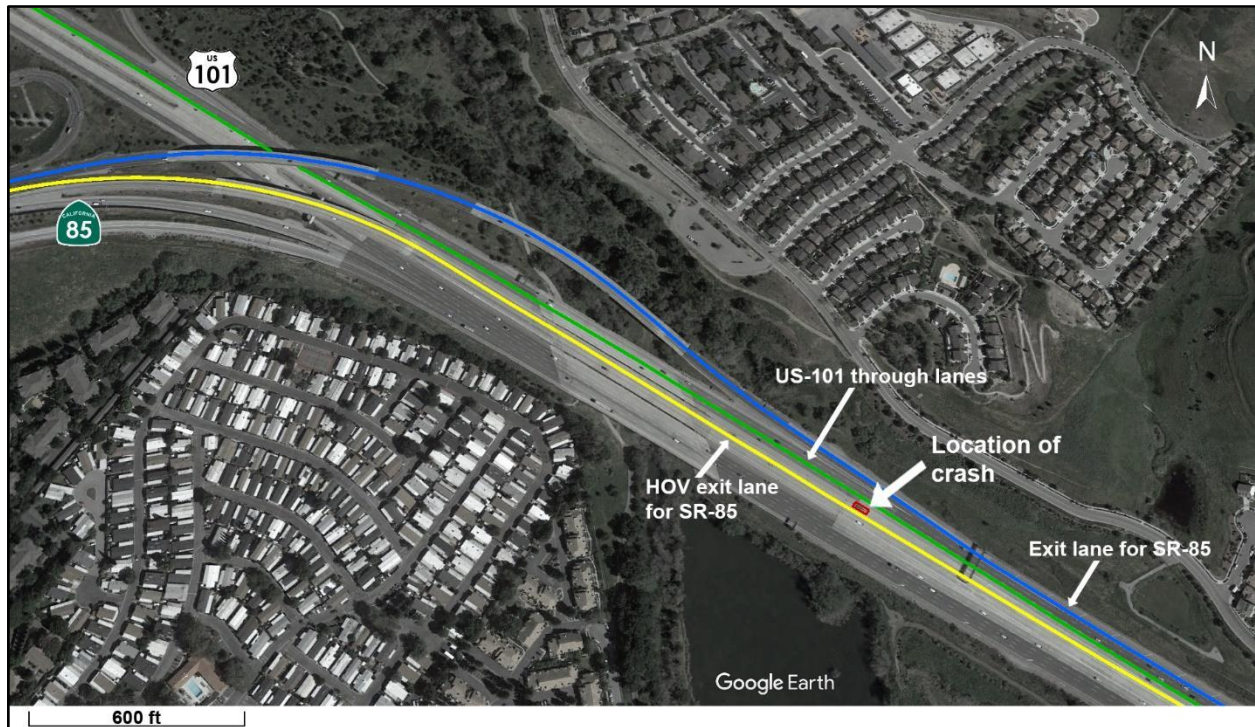
Greyhound provides paper-based directions to drivers who are assigned new routes. The directions for route 6876 suggest that drivers departing from Gilroy take US-101 north to Interstate 280 north, not SR-85, to reach the San Jose bus terminal. According to those directions, the driver should have remained on US-101 for another 8 miles (green route in figure 11).⁵¹ Instead, on the day of the crash, the driver said that he had intended to take the left exit HOV lane for SR-85 (yellow route in figure 11). Five days earlier, based on data obtained from Cadec, a fleet management system, the driver had taken the right exit (non-HOV) lanes for SR-85 (blue route in figure 11).⁵²

Figure 11. US-101–SR-85 interchange showing crash location: yellow line marks driver's intended route on day of crash, blue line marks driver's route 1 week prior to crash, and green line marks Greyhound-prescribed route. (Source: Google Earth, depicting crash location on January 26, 2016)
